Brickwork

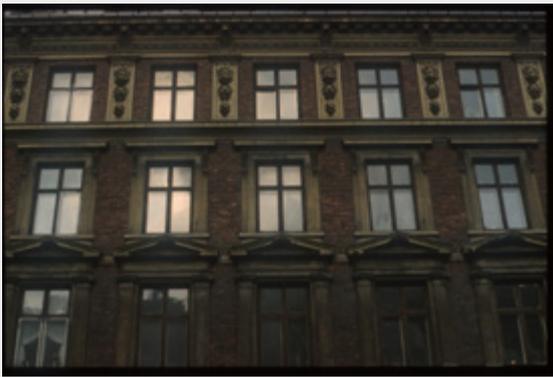
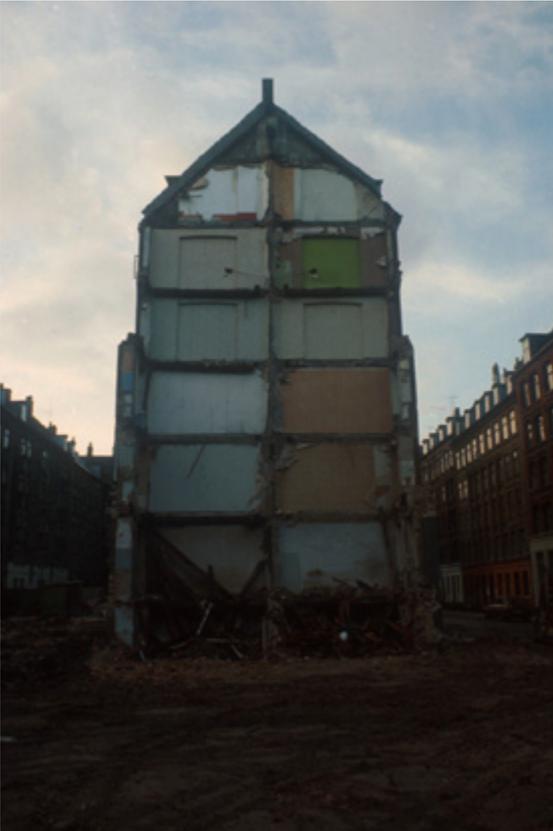
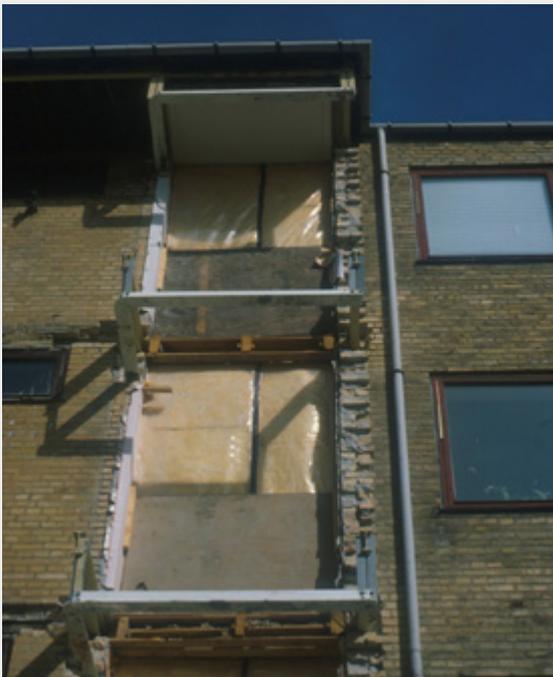
Note to illustration 2. "Brickwork" in the Gallery:

Brickwork at facade and gable in typical (Copenhagen) apartment building, and with internal timber walls in normal floors, maximum window openings in the facade and blinding wall at the gable. On the left we see foundation walls in the basement floor, and in the facade the brickwork that is supported by wall planks; to the right are the foundations, and the facade without the brickwork supported by wall planks. (Københavns etageboligbyggeri 1850-1900, Engelmark, 1983)
