Ventilation

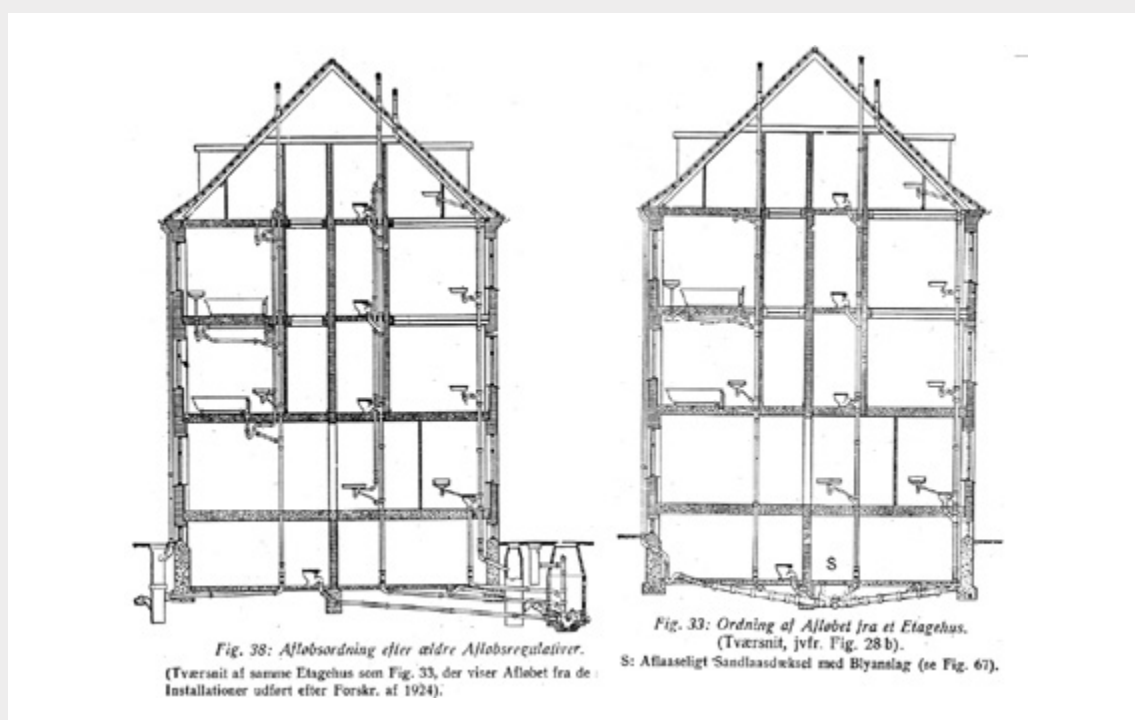
Note to Illustration 1. “Ventilation of drains” in the Gallery:

In buildings erected up to the mid-1920s, it is possible to find pipes for ventilating water traps – pipes which are (probably) no longer in use, because the drainage systems have since been replaced. The figure on the left shows the possible extent of such ventilation pipes, while the figure on the right shows the later situation without such ventilation. (Bygningshygiejne, Eilertsen 1938)

However, the functionality of water traps was dependent upon the water not being sucked out. Consequently, many parts of the country had a special requirement for drains to be ventilated after the water trap and before connection to the waste pipe. These requirements ultimately affected drains from hand basins, bathtubs and floors, etc. as well.
